**HTT Flooring - Herringbone Engineered Range - Wet Sliptest SN170723-5** 17 Jul 2023

**Slip Resistance Classification of New Pedestrian Surfaces - AS4586:2013**

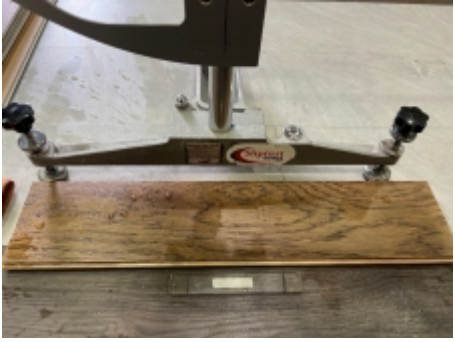
Sample No.	Swing 1	Swing 2	Swing 3	Swing 4	Swing 5	Mean BPN of last 3 swings :	SCV :	Surface Picture
Cuban	40	40	40	40	40	40	N/A

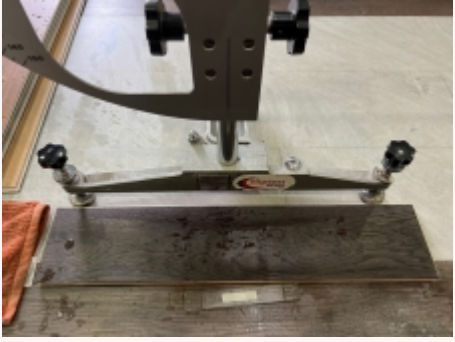
Brescia	46	43	41	41	41	41	N/A

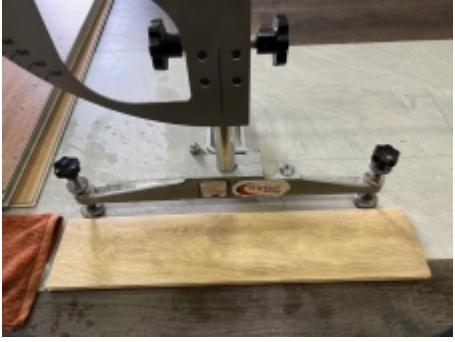
Lime Wash	46	46	45	45	45	45	N/A
